**Untersuchungsbericht 34/15**

**Sehr schwerer Seeunfall**

**Tödlicher Personenunfall  
an Bord des MS HANJIN DALLAS  
am 1. Februar 2015 vor der Ostküste USA**

**29. Januar 2016**

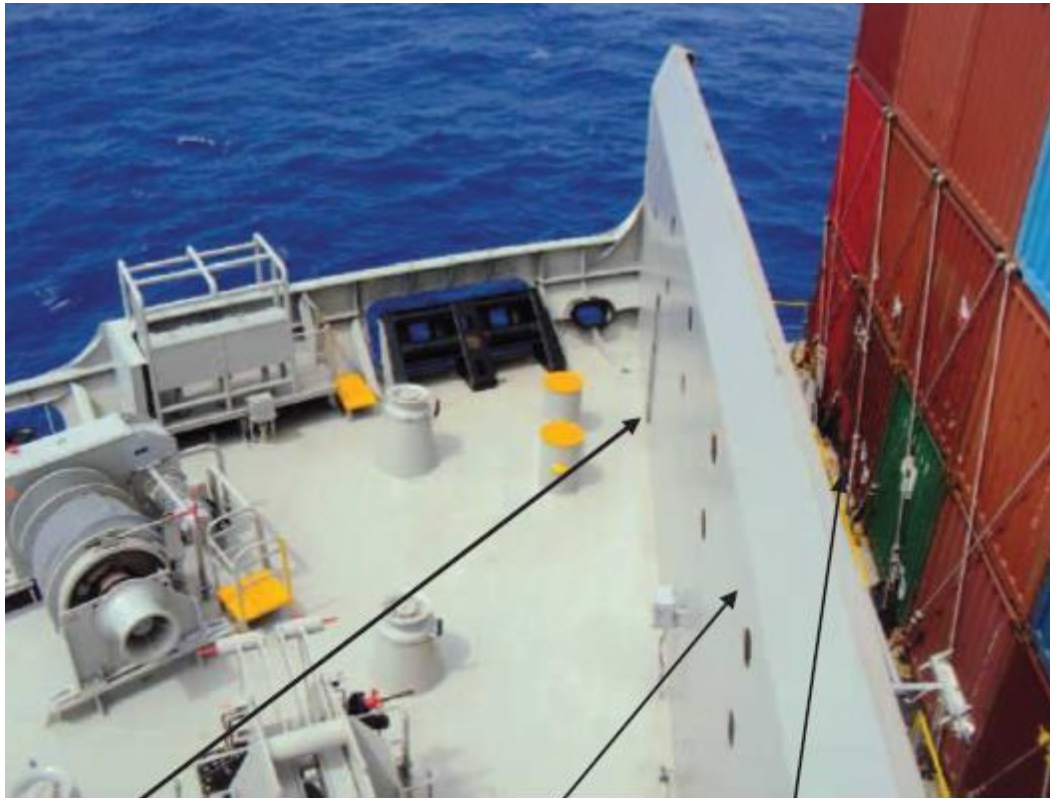
Abbildung 5: Unfallort, Ansicht von oben

Der Unfallort ist auf dem Vorschiff auf der Steuerbordseite. Vor der ersten Containerlage ist ein Wellenbrecher aufgebaut, der an beiden Seiten einen Durchgang zum Vorschiff hat.

Auffindeposition Verunfallter

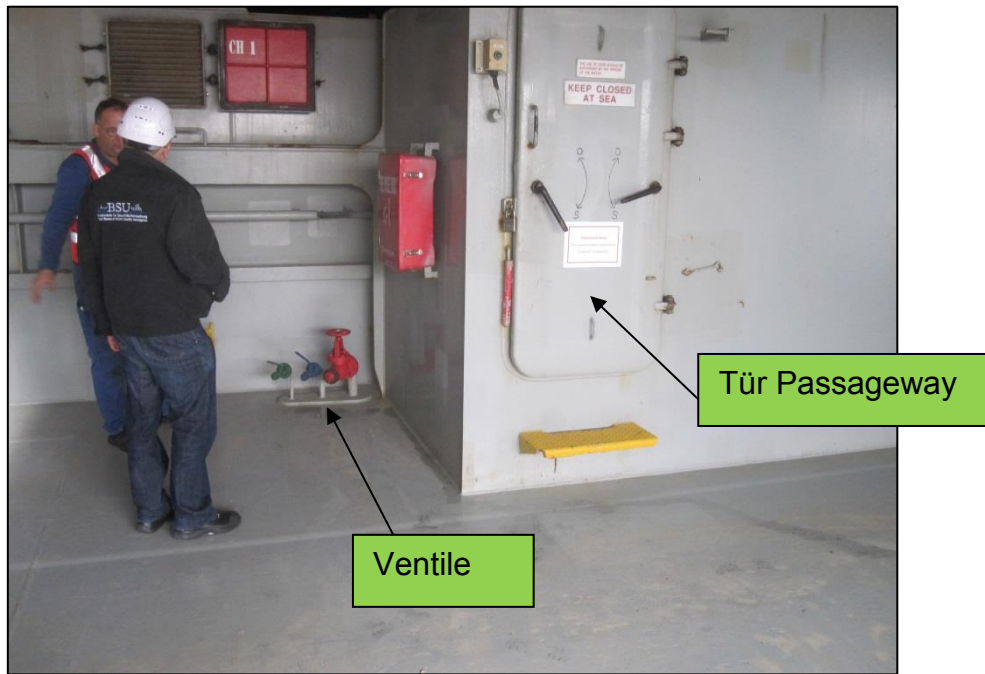
Abbildung 7: Ventile und Tür Passageway

Bei der Besichtigung der Unfallstelle im Hafen von New York wurde die Position des Verunfallten nachgestellt. Die Tür des Passageways war verschlossen, als der SM nach vorne kam. Es ist daher zu vermuten, dass der Bootsmann über die Backbordseite des Hauptdecks nach vorne gekommen sein musste.

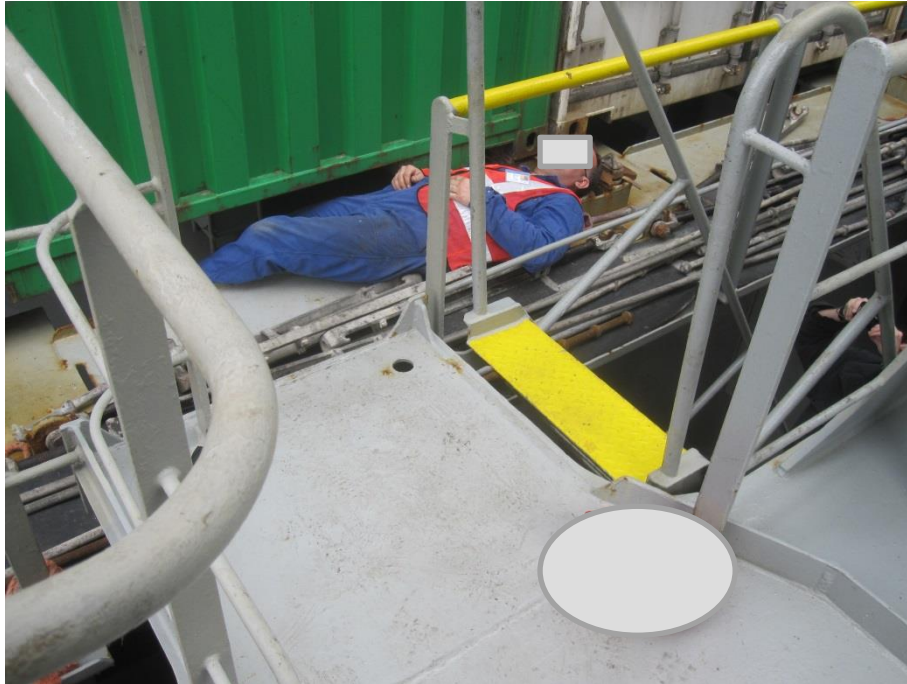
Abbildung 9: Blick von vorne durch den Wellenbrecher

Der Weg auf dem Hauptdeck auf Backbordseite führt zunächst auf der Wind- und Wellen abgewandten Seite in den geschützten Bereich Achterkante Back, hinter dem Wellenbrecher. Eine Treppe führt nach oben (letzte Stufe gelb gemalt) und endet hinter dem Wellenbrecher, dort wo sich der Durchgang vom Vorschiff befindet.

Der Bootsmann wurde hinter den Zurrstangen gefunden, die auf obigem Bild noch nicht gesetzt sind. Genau im Bereich der Auffindeposition befindet sich die Öffnung im Wellenbrecher zum Vordeck.

Der Bootsmann ist wahrscheinlich durch Wellenschlag am Durchgang des Wellenbrechers von den Wellen sehr unglücklich getroffen und gegen die Container gespült worden. Dabei hat er sich so schwere Verletzungen zugezogen, dass er später daran verstarb.
