Conducting Visual Surveys with a Small ROV in Shallow Water

Robert E. Pacunski and Wayne A. Palsson

Washington Department of Fish and Wildlife, Mill Creek, Washington

Abstract

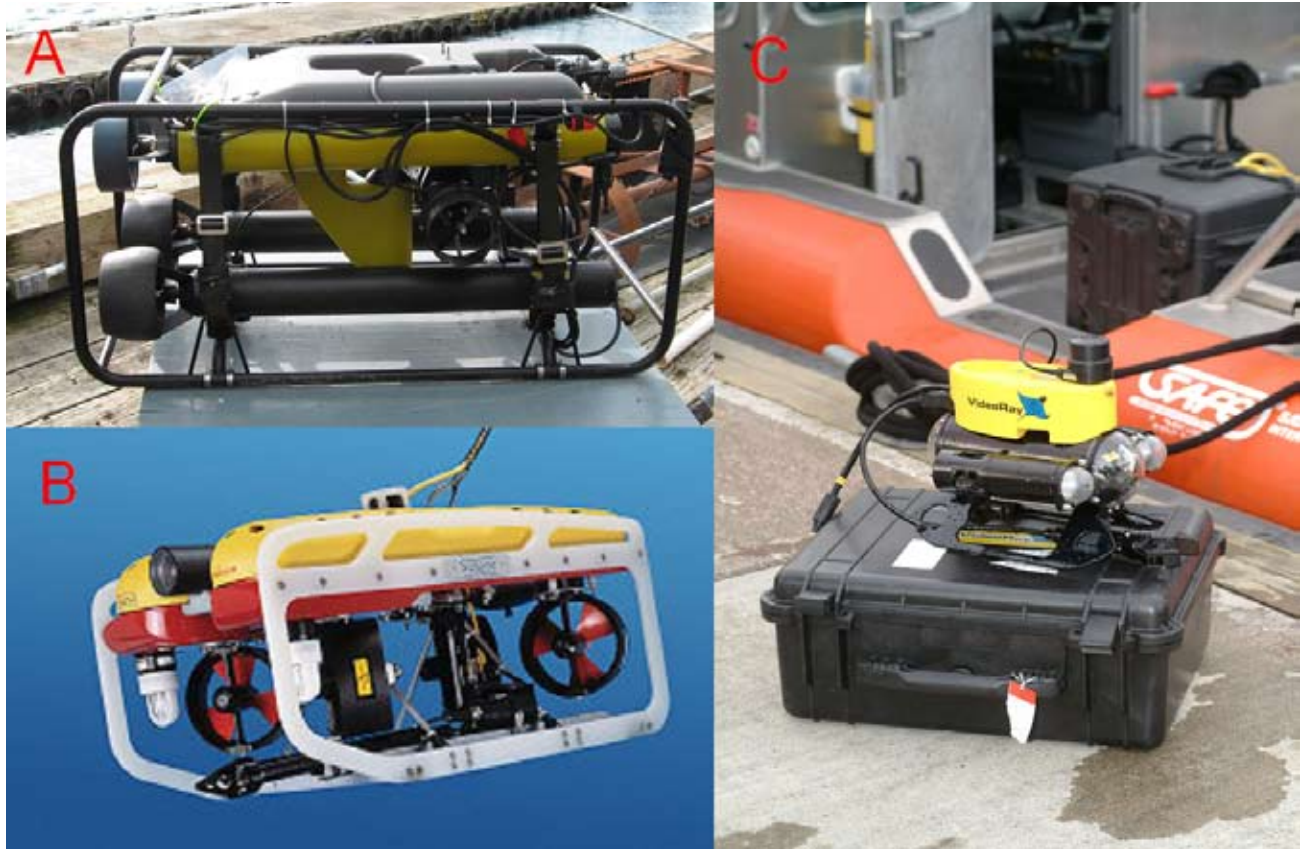
Figure 1. Examples of light-work and mini-class ROVs. **A:** Deep Ocean Engineering Phantom HD2+2. **B:** Seaeye Falcon. **C:** VideoRay Pro 3 XEGTO microROV.

In U.S. dollars, purchase costs for a base model Deep Ocean Engineering (DOE) Phantom HD2+2 (Fig. 1A) can range from \$85,000 (used) to \$100,000 US (new) (Mike Chapman, Mecco Inc., Duvall, Washington, 2007, pers. comm.), while the slightly smaller Seaeye Falcon (Fig. 1B) can be purchased for between \$125,000 and \$150,000 (Chris

Roper, Roper Resources Inc, Victoria, British Columbia, 2007, pers. comm.). The purchase price for a VideoRay Pro 3 (Fig. 1C), a high-performance mini-class ROV, is approximately \$28,000 (<http://www.videoray.com/>). The above costs do not include ancillary equipment such as tracking and navigation systems, imaging sonars, or laser systems, which can easily add \$15,000 to \$150,000 or more to the initial ROV purchase price.

The ROV used in both of our surveys was a DOE Phantom HD2+2, measuring 1.4 m long by 0.7 m wide by 0.7 m high and weighing 120 kg (in air) (e.g., Fig. 1A). Power is supplied by four ½ hp horizontal thrusters, one ¼ hp vertical thruster, and one ¼ hp lateral thruster, providing 68 kg of forward thrust, 7 kg of vertical thrust, and 7 kg of lateral thrust, respectively. The Phantom is equipped with a Sony EVI-330 high-resolution color zoom camera that can be tilted up and down; the camera was fixed at 45° below horizontal when conducting transects, a position that maximized coverage of the seafloor for data collection while providing the ROV

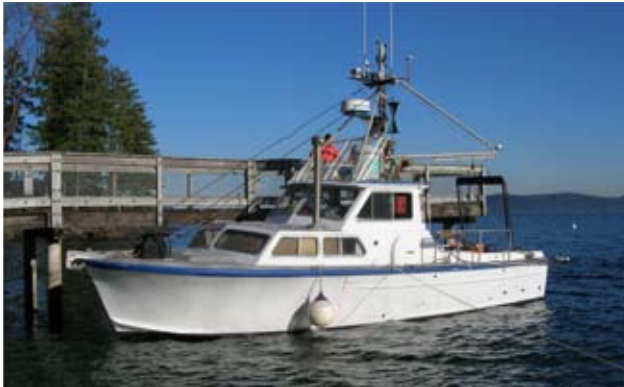
Figure 4. The R/V *Molluscan*, owned and operated by the Washington Department of Fish and Wildlife.

Csepp (2005) demonstrated the ability to conduct safe and efficient ROV operations from a vessel as small as 6 m. Using a DOE Phantom XTL, a lower-powered version of the HD2+2, and limiting operations to shallow water (<76 m) and relatively calm seas (waves <0.6 m), Csepp (2005) eliminated the need for hydraulic capabilities and required only a small (2 kW) portable generator for power, thus minimizing the size and space requirements of the vessel. Because our surveys were conducted in deeper waters and higher sea-states that increased the demands on the vessel and the ROV, we required a larger platform to accommodate the additional equipment and crew necessitated by these conditions. Our vessel, the R/V *Molluscan*, is a 12 m fiberglass center-wheelhouse monohull design with a beam of 4.5 m, equipped with a hydraulic deck winch and stern mounted A-frame (Fig. 4). The inherent stability of the R/V *Molluscan* facilitated ROV piloting and simplified tether management, enabling operations to be conducted in more extreme weather conditions than those described by Csepp (2005). The large, open deck provided adequate space for efficient

handling of the ROV and umbilical, and the removable transom boards expedited deployment and recovery of the ROV and other equipment. Because the San Juan Channel is a relatively small and protected geographic area, a lack of vessel speed and maneuverability were not liabilities in our surveys, although these characteristics may be important when operating across wider areas and/or in extreme weather conditions. For example, vessels operating in exposed coastal environments may be equipped with high-performance engines and dynamic positioning systems (e.g., R/V *Elakha*, Fig. 5), although these features may add considerably to vessel and operational costs.

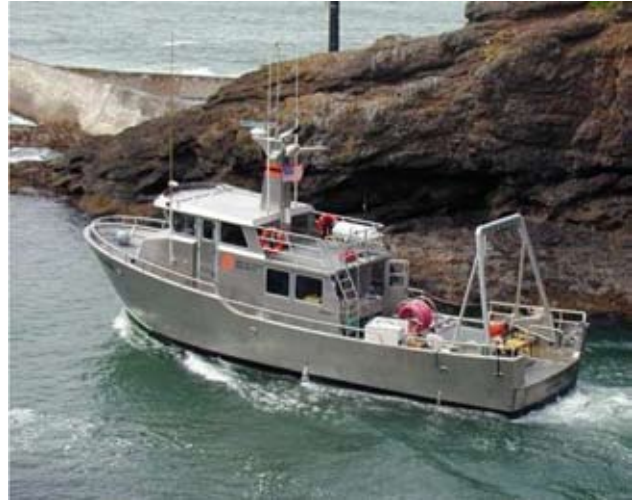
Figure 5. The R/V *Elakha*, owned and operated by Oregon State University. Note Phantom HD2+2 on rear deck and umbilical on reel behind cabin.

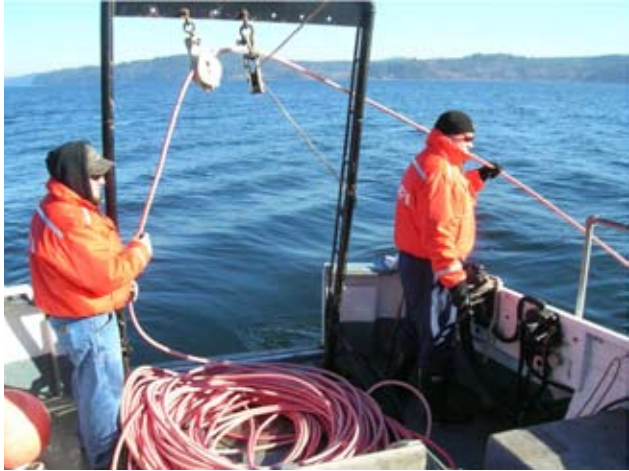
Figure 6. ROV umbilical coiled on deck of the R/V *Molluscan*.

The most common and least expensive approach to storing the ROV umbilical on a small vessel is to figure-8 or coil it onto the deck or into a well. To maximize deck space, we opted to coil the umbilical during our surveys (Fig. 6), although this method requires the umbilical to be flipped under itself every second or third coil to maintain the natural twist of the conductors. In contrast, the figure-8 technique reduces handling time by eliminating the need for flipping, and is preferred when space is available. A more sophisticated but expensive method involves the use of a slip-ring and reel system. These systems can be manually or automatically controlled (Fig. 7), but can also be large and heavy, and may require the use of a larger and/or dedicated vessel.

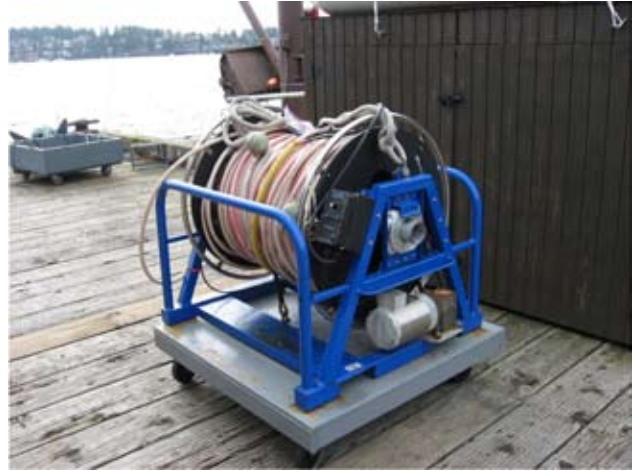
Figure 7. Motorized slip-ring and reel system for a Phantom umbilical. This unit is owned by the University of Washington Friday Harbor Laboratories.

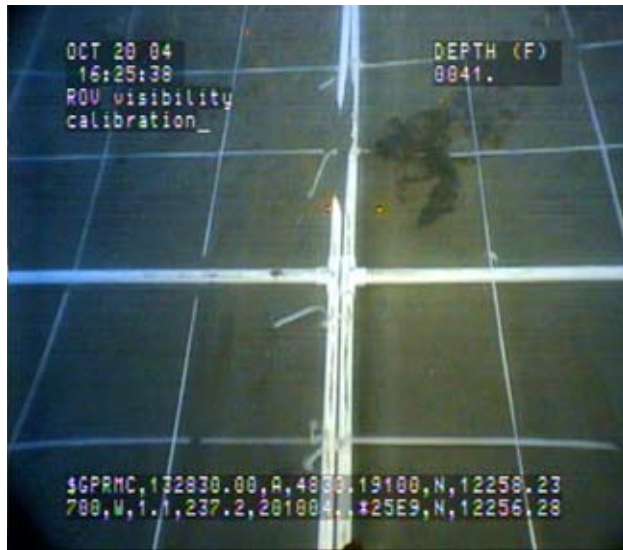
Figure 15. ROV calibration grid. Note laser dots for scale (10 cm separation).

where W_m is the width of the video monitor (m), W_l is the laser width (m) measured on the video monitor, and 0.10 is the fixed laser separation distance in meters. During videotape review, laser measurements were taken at 60 second (± 10 second) intervals along each transect and averaged to

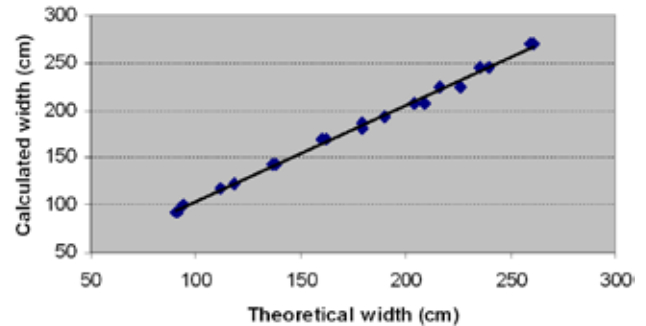
Figure 16. Relationship of theoretical transect width to calculated transect width, from grid calibration tests.

obtain a mean transect width. All measurements assumed a flat substrate with the ROV flying a level attitude. The accuracy of this method was tested by driving the ROV at different altitudes over a measured grid deployed on a flat bottom (Fig. 15). The regression of estimated transect width to the measured width on the video monitor was nearly perfect, with an R^2 of 99% (Fig. 16).

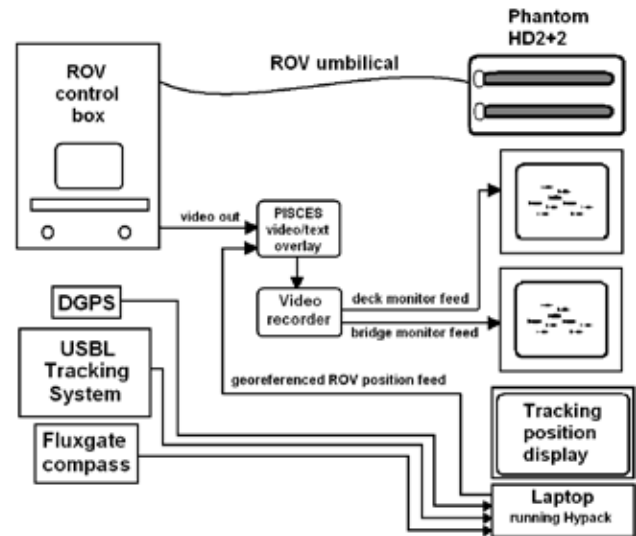
Figure 18. Equipment schematic for ROV system used in 2004 and 2005 San Juan Channel surveys.

The key to achieving maximum efficiency in our surveys revolved around a coordinated and consistent approach to all aspects of the operation. By developing and posting equipment schematics (Fig. 18) and checklists for the various procedures in our surveys (e.g., equipment startup, hydrophone, and ROV deployment), we were able to minimize mistakes and maintain safe working conditions. A troubleshooting table was developed for identifying and correcting some of the more common problems we encountered before they could have serious impacts on our operations (Table 3). The use of logbooks to document ROV and equipment use, service, and repairs is highly recommended. We consistently documented problems in as much detail as possible, which proved invaluable in the diagnosis and resolution of new and recurring problems.
