**Untersuchungsbericht 34/15**

**Sehr schwerer Seeunfall**

**Tödlicher Personenunfall  
an Bord des MS HANJIN DALLAS  
am 1. Februar 2015 vor der Ostküste USA**

**29. Januar 2016**

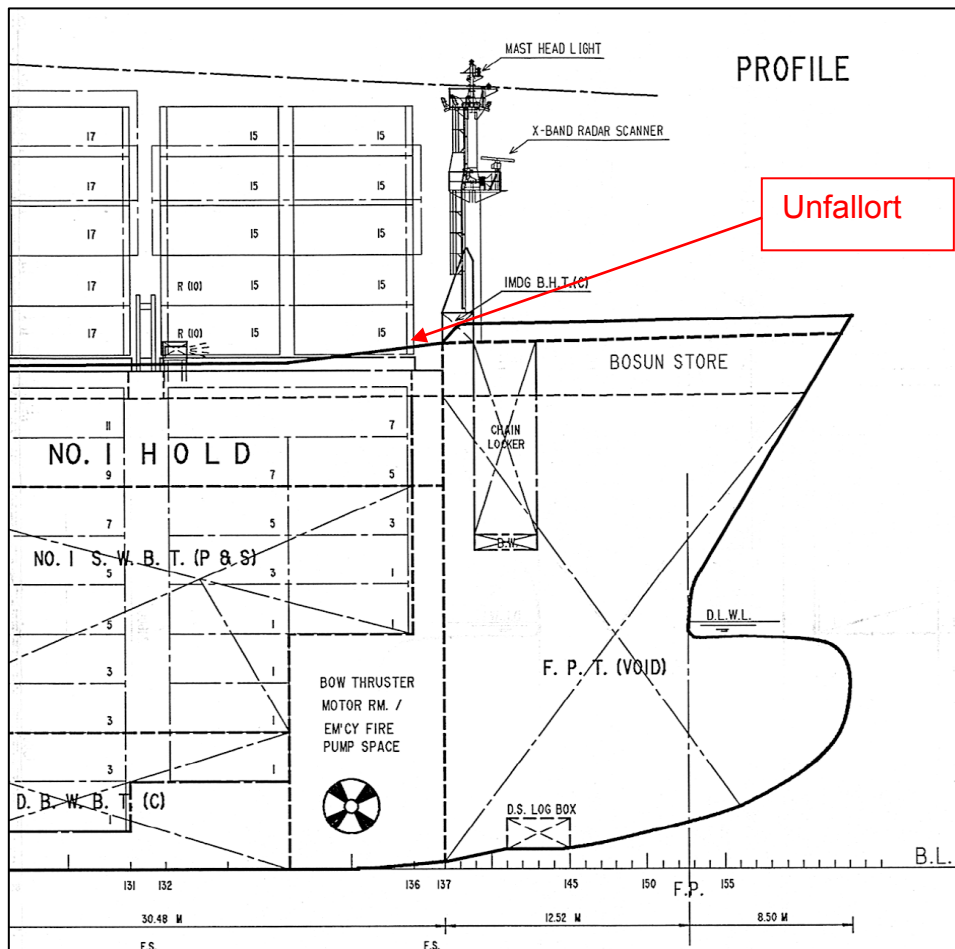
Abbildung 3: Auszug Generalplan, Seite

Die MS HANJIN DALLAS befand sich auf einer Reise von Singapur nach New York. Am 1. Februar 2015, gegen 10 Uhr, wurde der 50-jährige Bootsmann vom Schiffsmechaniker leblos hinter den Container-Zurrstangen auf einem auf dem Vordeck auf Steuerbordseite befindlichen Lukendeckel liegend gefunden.
